THE PASSIVE OPTICAL SAMPLE ASSEMBLY (POSA) - I EXPERIMENT:

ABSTRACT

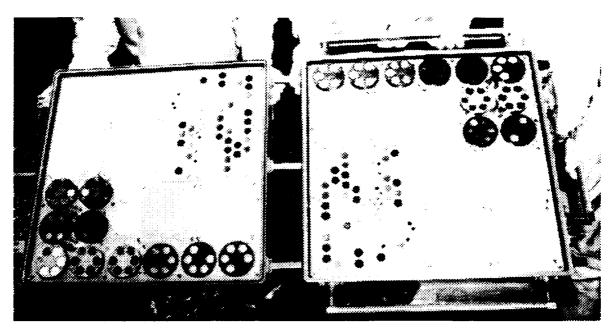
Figure 1 POSA-I Flight Hardware

POSA-I samples were placed in a Passive Experiment Carrier "suitcase" with o-ring seals (Figure 1) so that the samples were protected until deployment on the Mir docking module by EVA during the Space Shuttle mission STS-76. The Passive Experiment Carrier (PEC) was designed by Langley Research Center for all of the MEEP experiments. After being attached to the docking module, the astronaut unfolded the suitcase, so that half of the samples faced the Mir core (Figure 2) and the other half faced space. The PEC used a unique 360 degree double hinge which functioned smoothly on orbit in microgravity. The PEC was removed during STS-86 after exposure to the Mir environment for 18 months.
